Memorandum

Reference Reach Evaluation for Cottonwood Creek Reclamation Project

Date: November 22, 2006

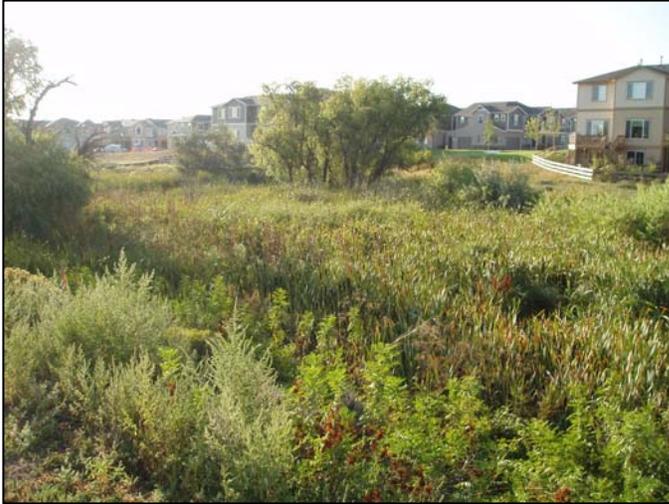
Figure 2. Wetland and Riparian Vegetation Associated with Increased Flows along Cottonwood Creek.

Two major responses to increased flows are evident along reaches of Cottonwood Creek near the project location. First, there has been an increase in wetland and riparian vegetation along the creek, particularly within about two to three feet (measured vertically) above the streambed. Figure 2 shows a photograph of the increased vegetation that has developed along Cottonwood Creek. The increase in flow and vegetation in these reaches has generally had a positive effect with respect to stream stability, habitat, and water quality. Cottonwood Creek in these reaches emulates the healthy stream corridor illustrated in Figure 3.

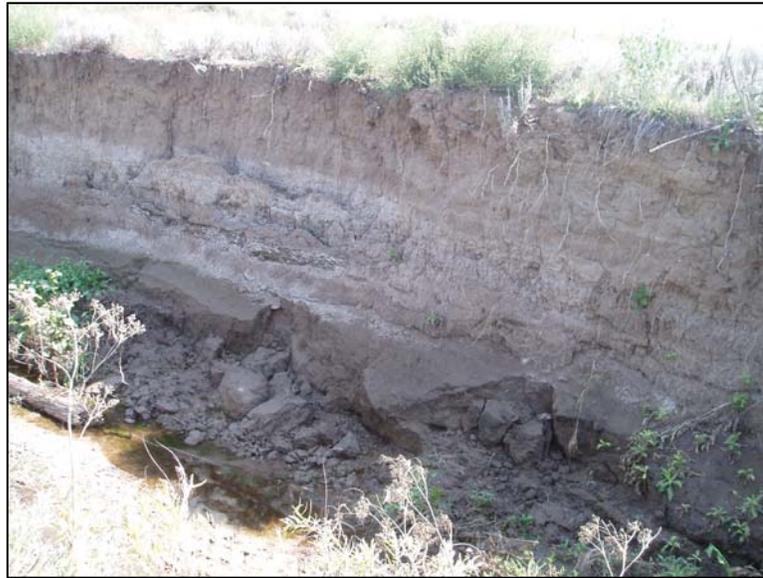
Figure 4. Degraded Reach of Cottonwood Creek.

The second type of response to increased flows evident in less-stable reaches of Cottonwood Creek is degradation, a downcutting of the channel invert through headcutting and erosion. Figure 4 shows a degrading reach of Cottonwood Creek. Degradation is normally associated with a significant short-term loss of stream benefits, as discussed below and illustrated in Figure 5.

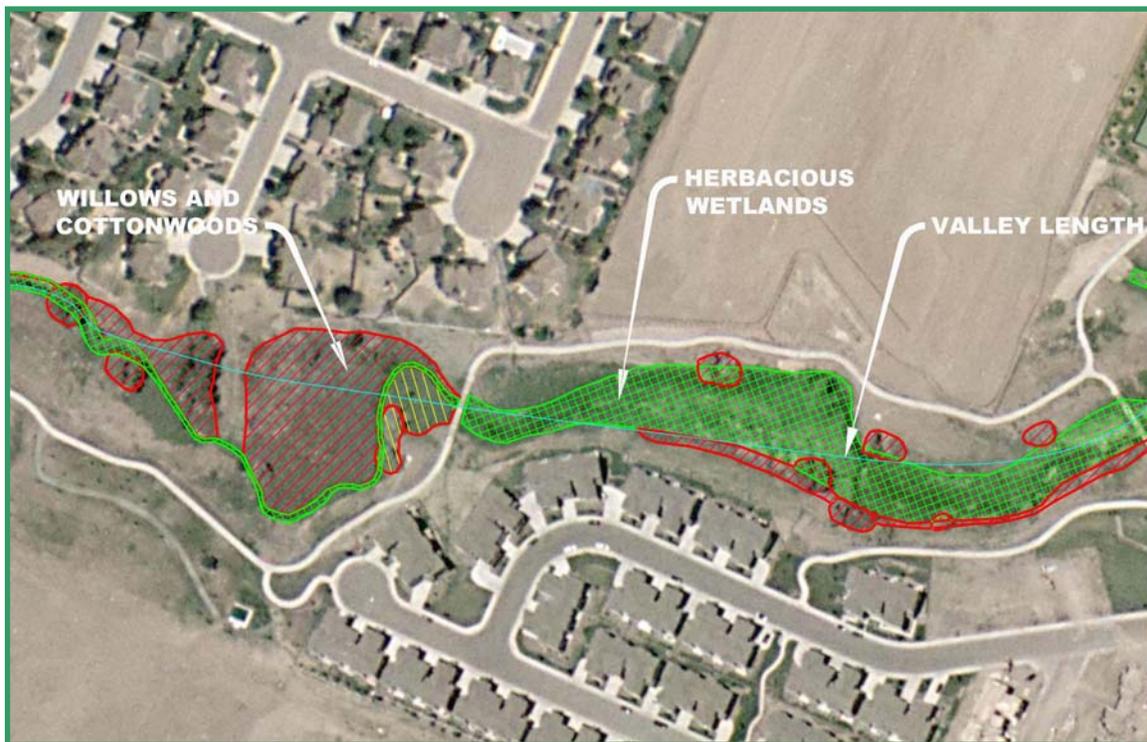
Figure 7. Cottonwood Creek Reference Reach.

Recent (July, 2006) aerial photography was obtained for the project area showing the reference reaches and the Phase 1 and Phase 2 project reaches. The summer growing conditions allowed wetland and riparian vegetation to be identified on the photography and a two-day field reconnaissance ensured that the delineation accurately represented field conditions. Two basic categories were established. Open water, wetland grasses, sedges, rushes, and cattails were classified as *herbaceous wetlands*. Woody riparian vegetation such as shrub willows and cottonwood and willow trees were classified separately. These are the two main types of riparian vegetation associated with elevated evapotranspiration along the streams; vegetation outside these categories consisted of upland grasses hydraulically disconnected from the stream channels. Figures 7 and 8 show representative categories of riparian vegetation along the two reference reaches in plan view and Figure 9 shows a photograph of typical vegetation.

As a comparison, the same two categories of vegetation established along Phase 1 of the Cottonwood Creek Reclamation Project were assessed. Figure 10 shows a representative reach of the Phase 1 project in plan view and Figure 11 shows a photo of the completed reclamation work. Vegetation widths along the stream channel, even if associated with two channel branches or tightly meandering stream alignments, were averaged over the length of the stream valley (represented by a blue line on Figures 7, 8 and 10), providing a uniform means of comparing the widths of vegetation.

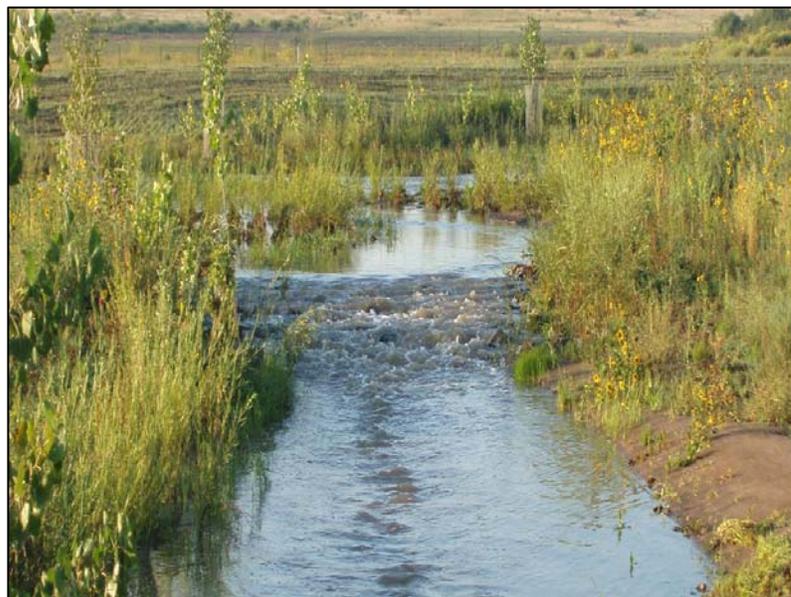
Figure 11. Typical Phase 1 Channel Reclamation.
